PROJECT: Midnite Mine Remediation

REPORT NO: 2019-002

MIDNITE MINE HEALTH & SAFETY SUMMARY: Reporting Period 04/05-04/11

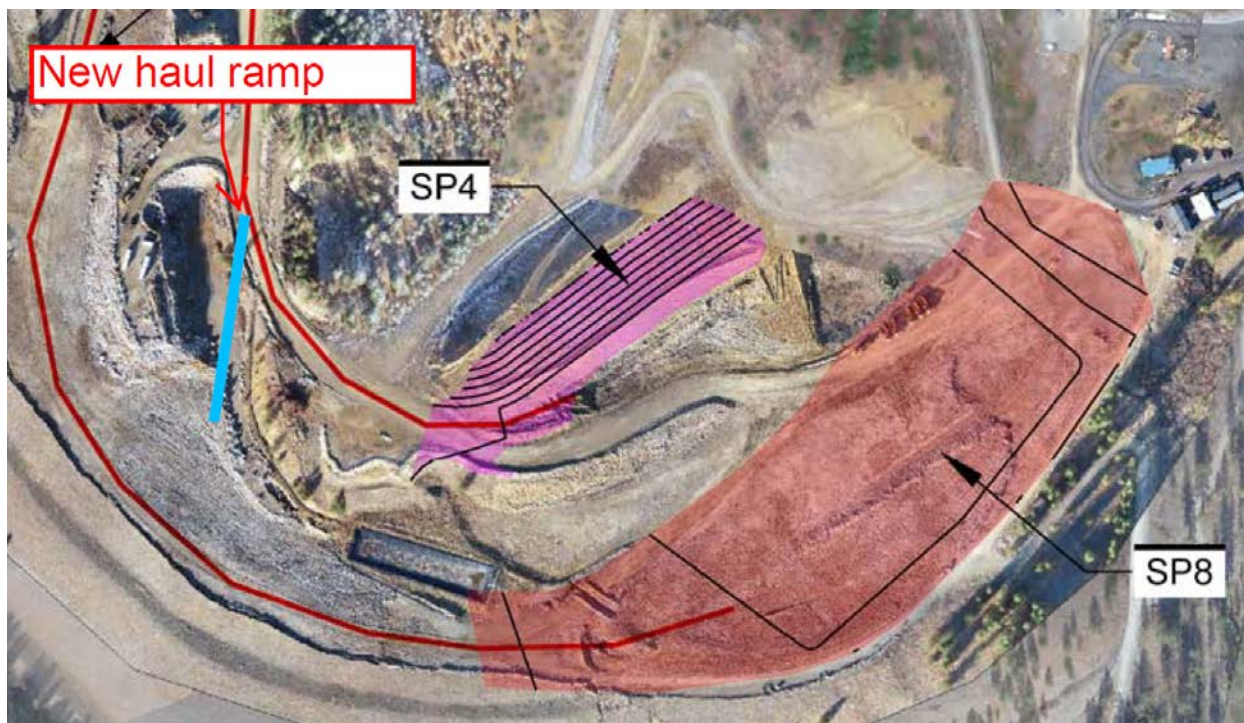
- Began constructing new access road ramp between utility crew trailers and existing haul road (see Figure 2 for location). The ramp is being constructed with material from the SWRP west of Lime Protore Stockpile 8 (SP8). This ramp will allow haul traffic to bypass hill at the toe of Ore Stockpile 4 and soft spots in the haul road across the western side of the SWRP.

Figure 1 – Teal line shows approximate location of the new haul road ramp.

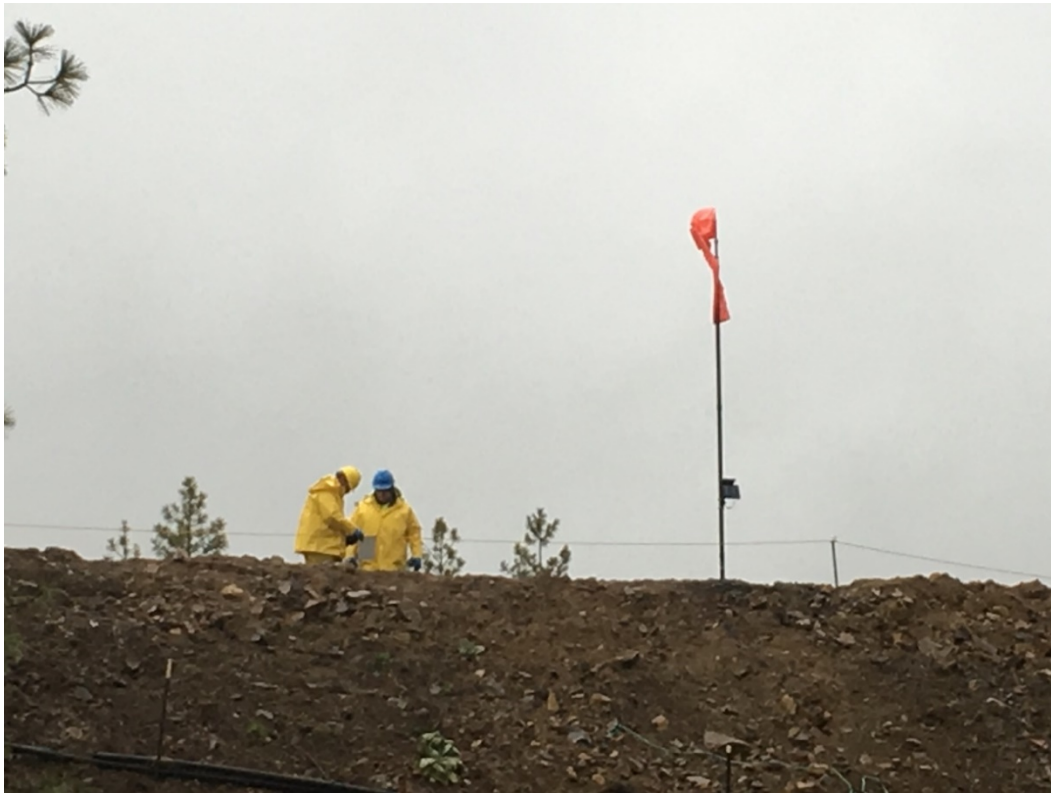
- The vertical dewatering riser heights remain at 200' for the Underdrain Sump (UDS) and 160' for the Waste Rock Dewatering Sump (WRDS).
- Construction crews repaired and replaced exclusion zone boundary rope and signage as needed (see Figure 3).

Figure 2 – Crew making repairs to exclusion zone signage near the Helipad located north of the field offices.

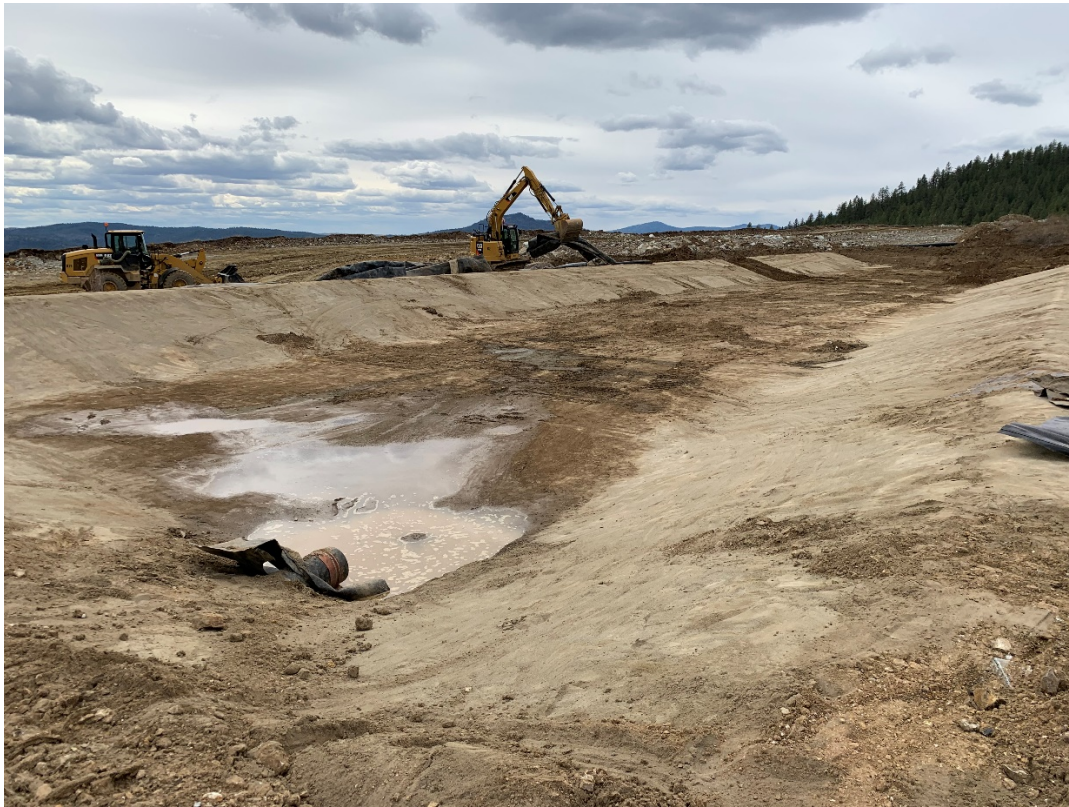
- Pit 4 tension crack was measured on April 10th. The horizontal distance between movement pins remains at 53.75 inches.
- The utility crew removed the liner from the 400,000-gallon pond on April 11th (see Figure 5). The liner will be disposed of as demolition debris in Pit 4.

Figure 5 – 400,000-gallon pond after the liner was removed.
